Disappearing Dealers

Progress Report:

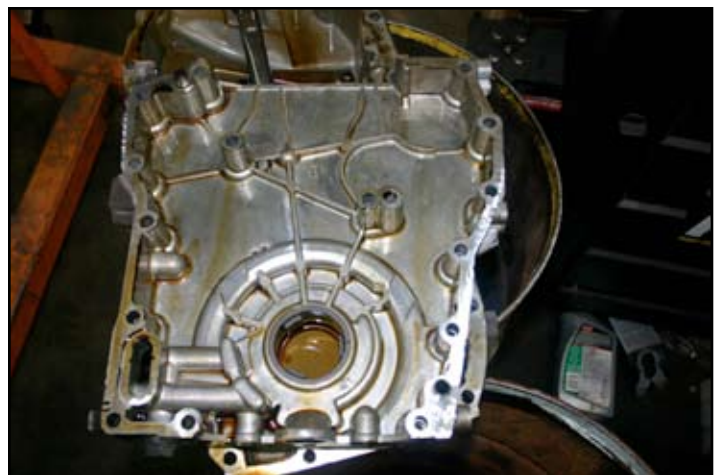
Internal side of the out-of-spec oil pump. There is no evidence of oil sludge or varnish deposits. All photographs by the author.

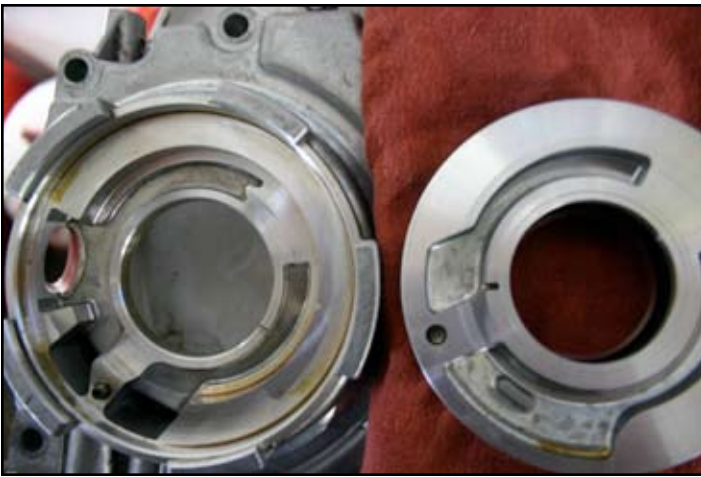
This is the gear cavity and cover of the out-of-spec oil pump that we installed at 89,000 miles and removed at 122,000 miles on my 2001 9-5 Aero. The publicity about the out-of-spec pumps and some e-mails got GM to correct the poor quality control. The current oil pumps available through Saab are excellent. This pump shows wear in the pump housing and pump cover. The oil pressure produced by this pump remained okay throughout the testing period of 33,000 miles. It was removed not because of any failure, but so we could move on to testing a custom built gear pump for a longer term. The pictured pump did a fine job during the testing timemile period, but could not have sustained the ultimate long life that we were looking for. It started with too much clearance, which with enough miles would have allowed it to produce less pressure.

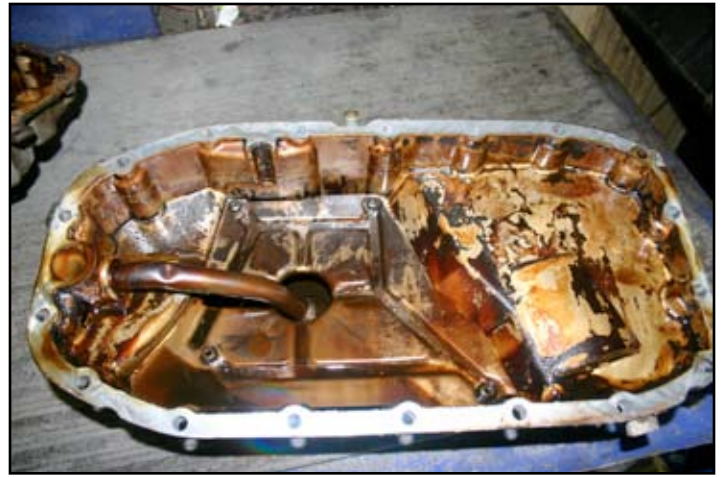
The oil pan is from a 2000 9-5 Aero at 72,000 miles. You can see the varnish and sludge baked on the surface. This residue will eventually end up in the oil pickup screen. The pan shown was removed in August 2008. The engine was so badly sludged that it had to be replaced.

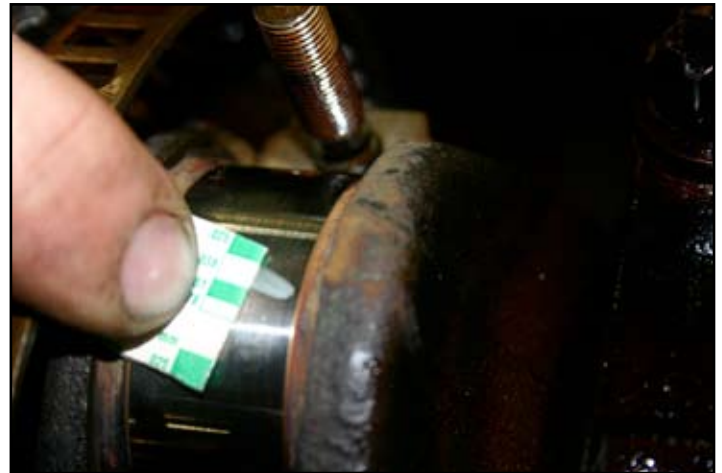
The way to measure engine bearing wear is by the use of plasti-gage on the crank shaft bearings. The picture shows a connecting rod bearing cap has been removed. A strip of plasti-gage laid on the crank shaft surface and the bearing cap is then installed and torqued to crush to the plasti-gage. The cap is then removed and the compressed plasti-gage is measured. The measurement in this case was .038mm. That is near perfect for this engine. Our system not only saved this engine from further damage (when we discovered the sludge) to making it possible to last a long, long time. How long will these low-friction engines go? In our customer base, we have half a dozen with cars in the 230,000 mile range, a 1999 9-5 wagon with 268,000 and a 2000 wagon with 286,000. They have used our de-sludge and maintenance recommendations. It works! These are great engines that will go the distance if they are internally clean and maintained. My controlled 33,000 mile test is just the start. I guess I'm going to have to keep my car forever to prove how long they will go with controlled care and maintenance.

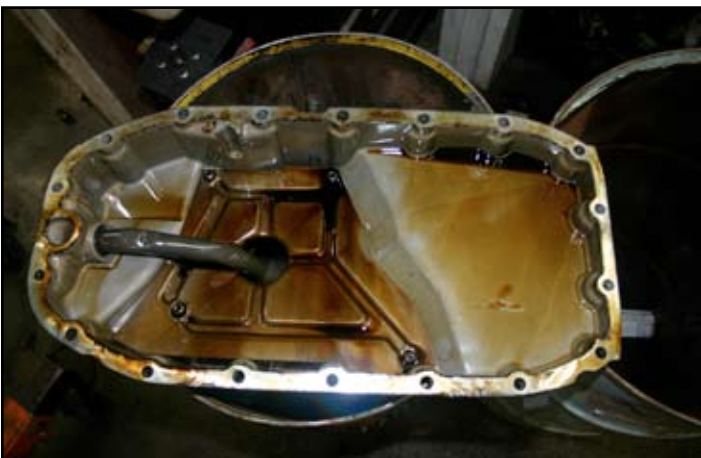
On the left is the debris-accumulator oil pan installed at 89,000 miles and removed at 122,000 miles when we changed oil pumps. Notice that there is not varnish or sludge deposits baked on the surface. 33,000 miles of service and all you see is the oil on the surface. I didn't wipe the oil out so you can see that there were no deposits baked or otherwise on the surface of the pan. The catalytic converter shield used on this car is one of the keys to this condition. The heat is shielded from the oil pan so the oil is not baked in this area.
