Professional Perspective

Silver Rapper

I decided at the last moment before writing this column to reiterate the dangers that oil sludging is creating. Many of you Saab owners have deluded yourselves into believing that it won't happen to you. I agree with Saab that only a small percentage (nobody knows how small or large) of the cars are affected, but it is nasty when you turn out to be in that minority.

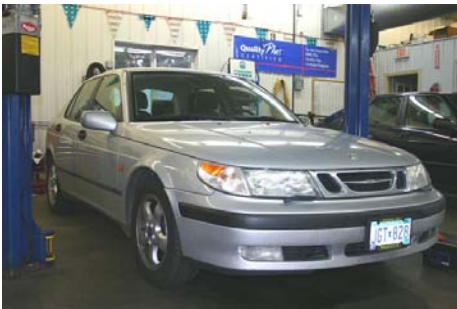
The silver 1999 9-5 (see picture) that I took in trade on October 1st with 120,000 miles on it was one of these

cars. The owner drove it for four years and loved the car! He intended to drive it for a long, long time. He had just purchased new front tires and recently replaced the turbo charger. Out of the blue, it started rapping. However, I have to believe it must have rattled from the loose balance/timing chains for some time. It was the scored #4 piston that caused the noise. The results are conclusive that the engine is sludged and absolutely worn out from lack of lubrication. Both the timing chain and balance shaft chain should have broken some time ago because they were so badly worn. The shop that had been servicing this 9-5 did the owner "no favors" by not recognizing the symptoms before the demise of the engine.

finding a sludged engine. At just under 79,000 miles, and with two oil samples, one at 4,000 miles and the other at 5,000 miles, we are now beginning to establish a wear pattern and an oil change interval. The results of the oil pressure, oil temperature, and turbo temps will enable us to supply very interesting and challenging information. I am currently experimenting with different oil cooler thermostats, turbo cool-down times, and water temps. Heat causes oxidation that I believe is the root cause of the problems with a less-than robust oil pump deteriorating prematurely. I think the evidence I present will show how easy it could be to prevent sludging and save these sludged engines if caught early. I think my Aero is going to be just fine and I think H.C.'s Aero will be okay too. However, the silver rapper will get a different engine and with a little TLC, it will serve someone for many, many years.

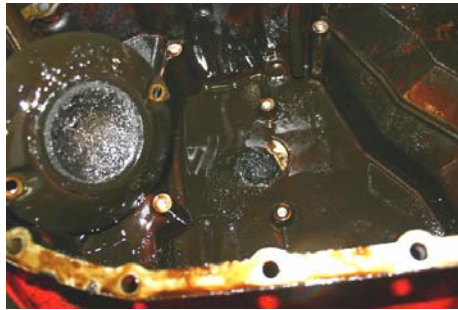
Rapper oil pan and pickup screen. All photographs by the author.

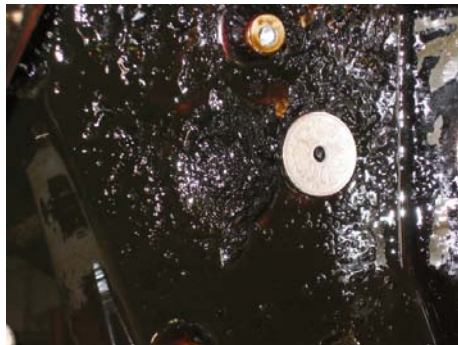
Oil pan showing debris in H.C. Thing's Aero. It is bad but not nearly as bad as the silver rapper!

and the rapper. The records on H.C.'s Aero show service had been done from day one to a "T" by an authorized dealer. Since **H.C. had all the records**, Saab of Denmark agreed to repair his sludged engine. They replaced the oil pump, cover, oil pressure relief valve, a pipe and hose to the last update (this is a quote from H.C.). They checked the bearings with Plasti-Gage (included picture) that were okay. Saab put their full synthetic, 0W-30 oil in the engine after which H.C. did some testing. I'll have more on these tests later as I'm able to compare his Aero and mine.

It is quite evident to me that if Saab changed the oil pump with no evidence of engine wear, they have to know how weak and vulnerable it really is. The oil pump is not cheap or easy to change. H.C.'s Aero was destined for an early demise had he not caught the sludge problem. I didn't even try to verify the service on our silver rapper. I know the owner had treated the car like any other Saab.

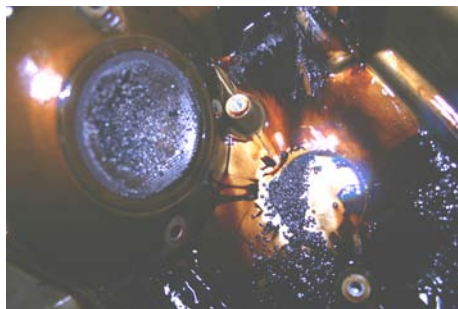
Oil pan showing sludge in author's Aero. Notice that it has much less than the others but would become a big problem if left unchecked.

Now, I get to confess that I am as guilty as many others thinking I wouldn't have a sludge issue with my car. As part of the gauge installation, we removed the oil pan to install the oil temperature sender. Guess what we found? My pampered Aero had what I see as a significant layer of sludge in the pan. My 4,000 mile-oil changes with Mobil 1 10-30 synthetic oil had not corrected any problems that the engine may have had. I had completed five oil changes up to that point with no indication of sludge. I had experienced no turbo smoke or timing/balance chain noise that is sometimes a precursor to

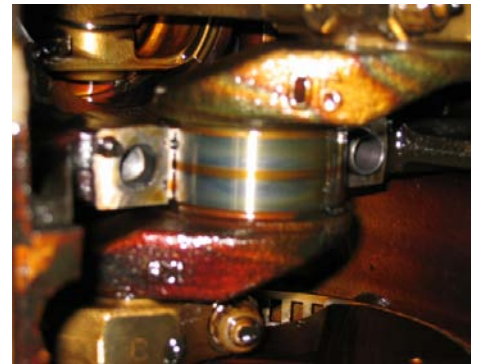
Main bearing journal with Plasti-Gage used to determine the bearing clearance from H.C. Thing's 9-5 Aero.

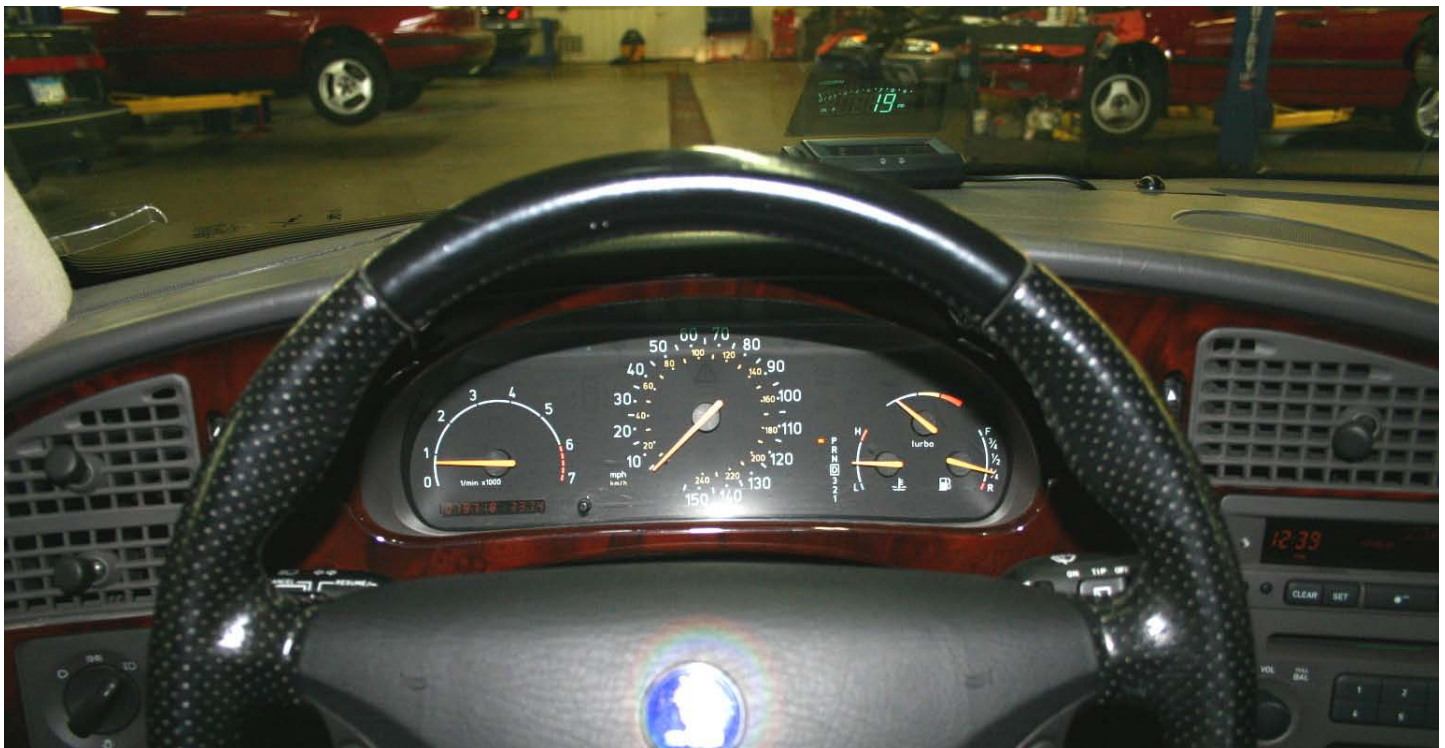
Gauge unit is set to the left of center over the defroster opening, showing the oil pressure reading at the time of the picture. It will be centered on the dash. The number is reflected to a green transparent screen/target that is movable. The numbers are very easy to read in any light and the intensity adjusts automatically as the outside light varies.

As a further point of information, I did get my gauges installed in my 9-5 and they are slick! I have to warn any of you thinking about these units that it takes some doing to get them installed. I am working out issues about some of the inaccurate readings. We have not been able to get the speedometer or the tachometer to work in the new unit but hope to be successful in the near future. I will have more on the gauge installation in future columns.
